U.S. Army Corps of Engineers  
Omaha District

**A SCOPING STUDY OF WATER QUALITY CONDITIONS  
IN THE MISSOURI NATIONAL RECREATIONAL RIVER  
REACH FROM NEAR GAVINS POINT DAM TO PONCA  
STATE PARK, NEBRASKA**

March 2002

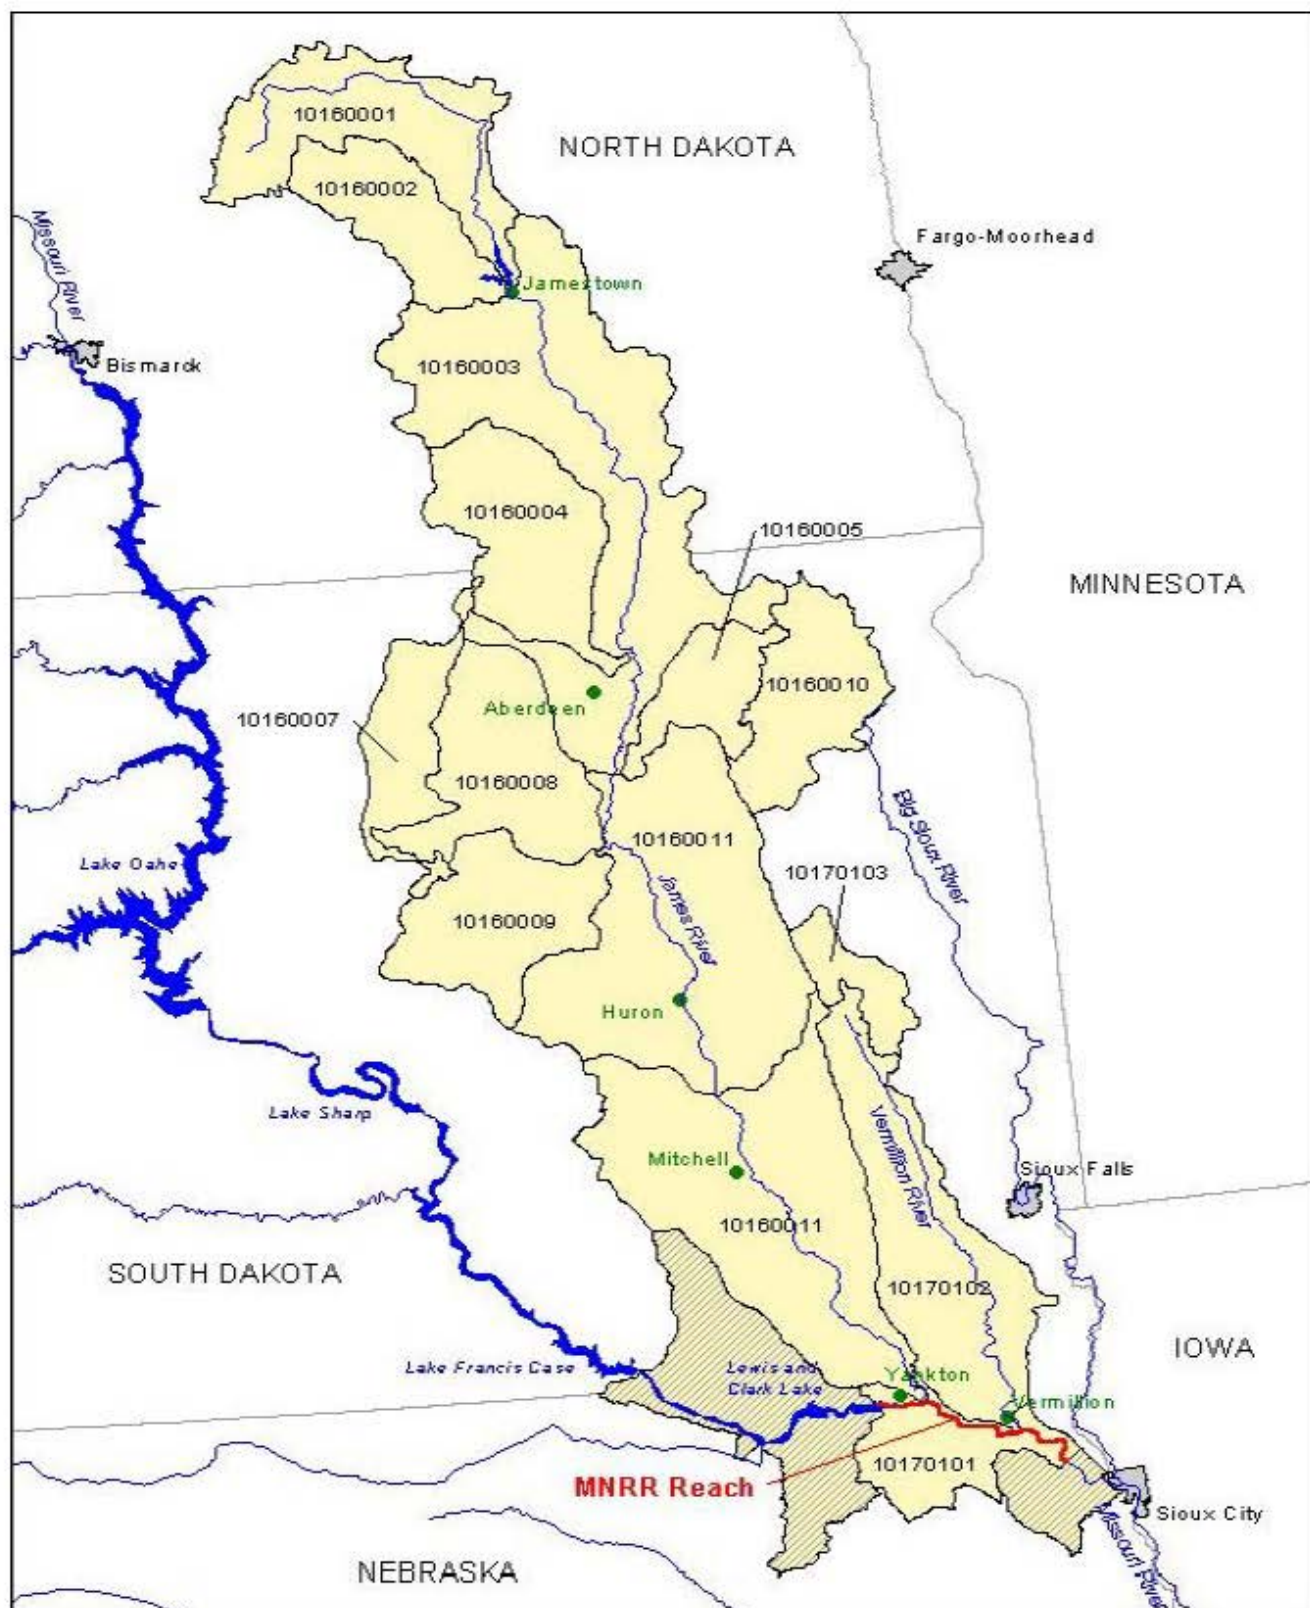
Plate 2. Watershed area draining to the MNRR reach below Gavins Point Dam as delineated by 8-digit Hydrologic Units (HUCs). Note: The "shaded" area of HUC 10170101 is the area above Gavins Point Dam and below Ponca, Nebraska that does not contribute runoff to the MNRR reach.

The 8-digit Hydrologic Units (HUCs) that make up the watershed of the MNRR reach below Gavins Point Dam are shown in Plate 2 and described in Table 1. The size of the watershed contributing runoff to the MNRR reach below Gavins Point Dam is approximately 25,120 square miles. Of the total 25,120 square mile watershed, approximately 21,590 square miles is in the James River watershed and approximately 2,650 square miles is in the Vermillion River watershed. Approximately 880 square miles is in the watersheds of the other tributaries discharging directly to the MNRR reach (mainly from tributaries in Nebraska). The coteau region, HUCs 10160007, 10160010, and 10170103 (2,530 square miles), are largely internally drained and generally non-contributing to surface water runoff within the watershed.

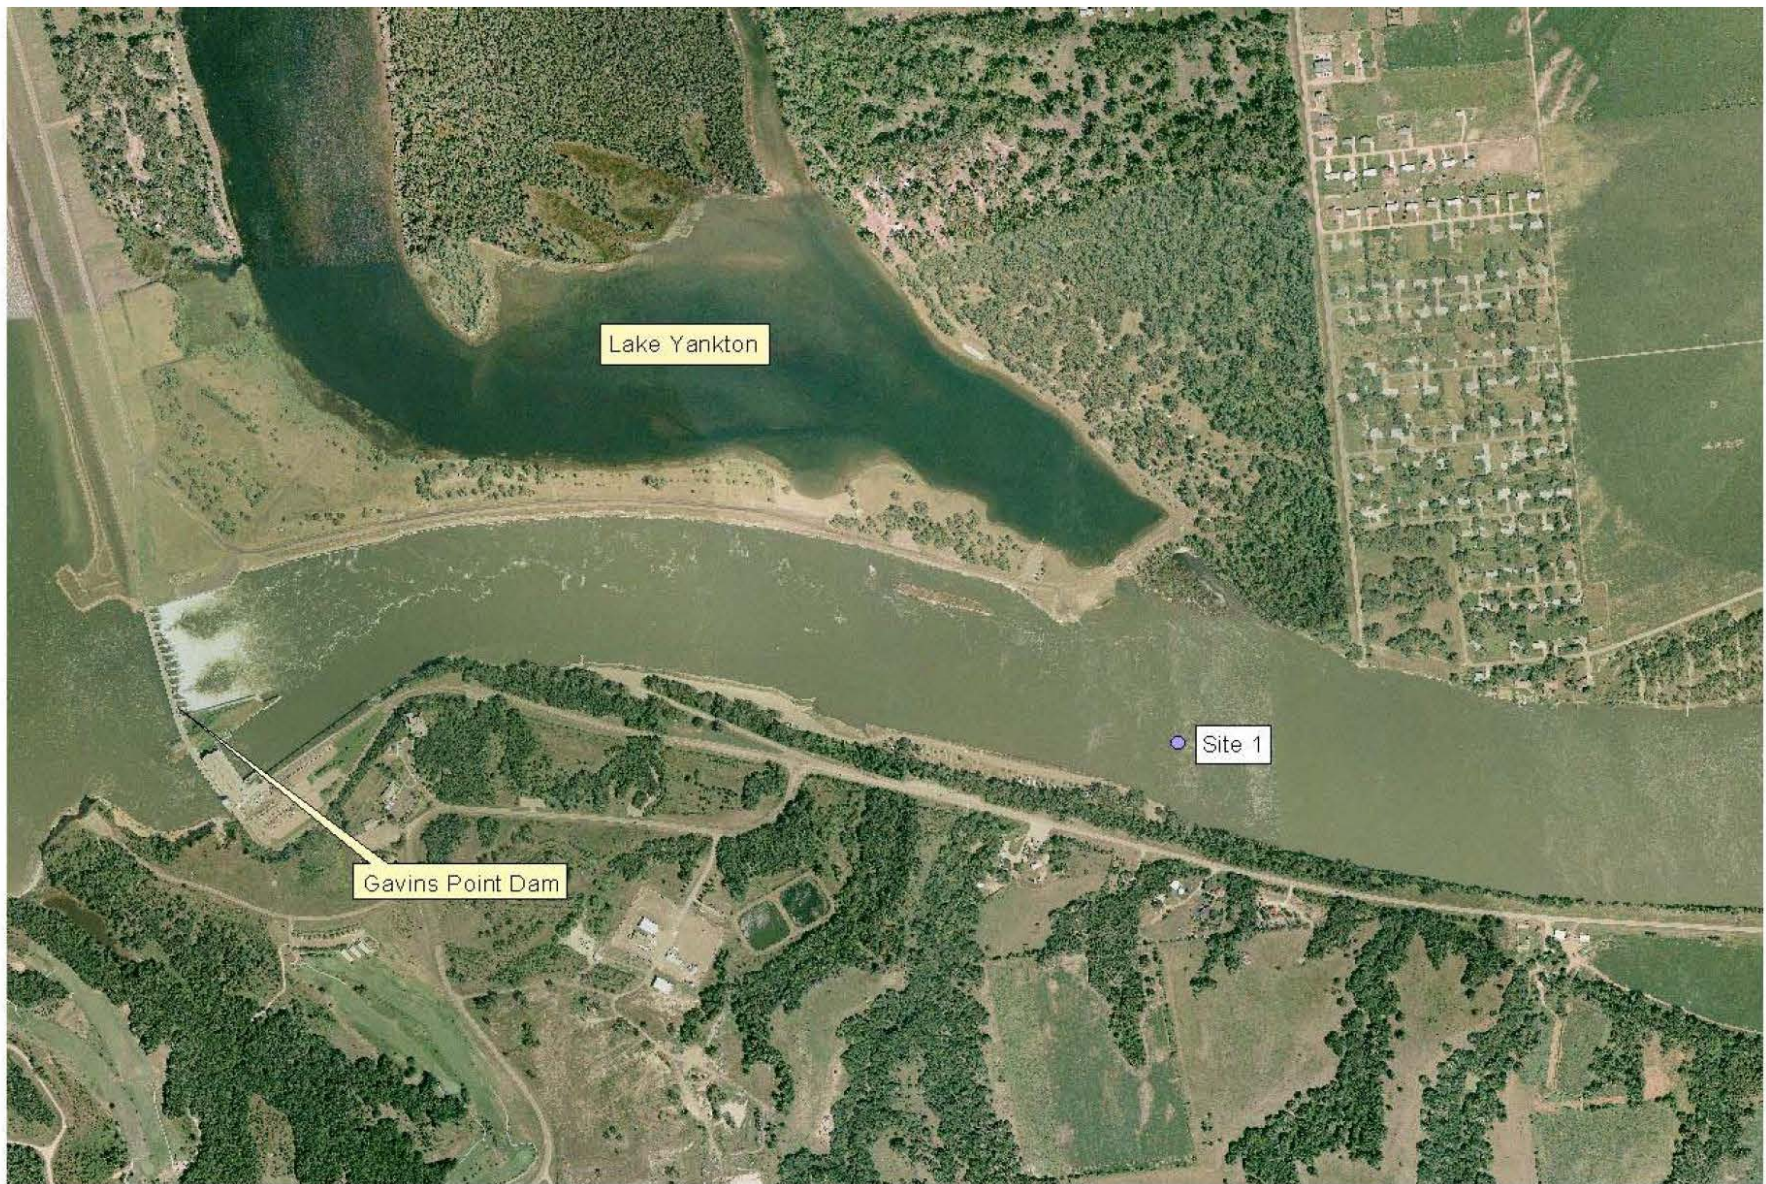
**Plate 4.** Location of Site 1 based on the average of the obtained GPS coordinates and projected on a 1997 orthophoto of the area.

A total of nine monitoring locations were established on the Missouri, James, and Vermillion Rivers as part of the scoping study (Plate 3). Location 1 was on the Missouri River approximately 1 mile below Gavins point Dam at Missouri River Mile (RM) 810 and consisted of a thalweg site only (Plate 4). Location 2 was on the Missouri River, approximately 0.5 miles above the confluence of the James River at RM 801, and had both a thalweg and backwater site (Plate 5). Location 3 was on the James River approximately 0.5 miles upstream from the Missouri River, and water quality samples were collected at a single mid-channel site (Plate 5). Location 3T was located on a side channel of the Missouri River that received the inflow of the James River, and four sites (3T1, 3T2, 3T3, and 3T4) were sampled along an approximate 2 mile distance of the side channel downstream from the mouth of the James River (Plate 5). Location 4 was on the Missouri River, approximately 1 mile below where the side channel receiving the James River flow enters the main channel flow of the Missouri River at RM 797, and consisted of both a thalweg and backwater site (Plate 5). Location 5 was on the Missouri River approximately 1 mile upstream from the confluence of the Vermillion River at RM 774, and consisted of both a thalweg and backwater site (Plate 6). Location 6 was on the Vermillion River approximately 0.5 miles upstream of its confluence with the Missouri River and water quality samples were collected at a single mid-channel site (Plate 6). Location 7 was on the Missouri River, approximately 0.5 miles below the confluence of the Vermillion River at RM 771, and consisted of both a thalweg and backwater site (Plate 6). Location 8 was on the Missouri River at Ponca State Park, Nebraska at RM 753 and consisted of both a thalweg and backwater site (Plate 7).

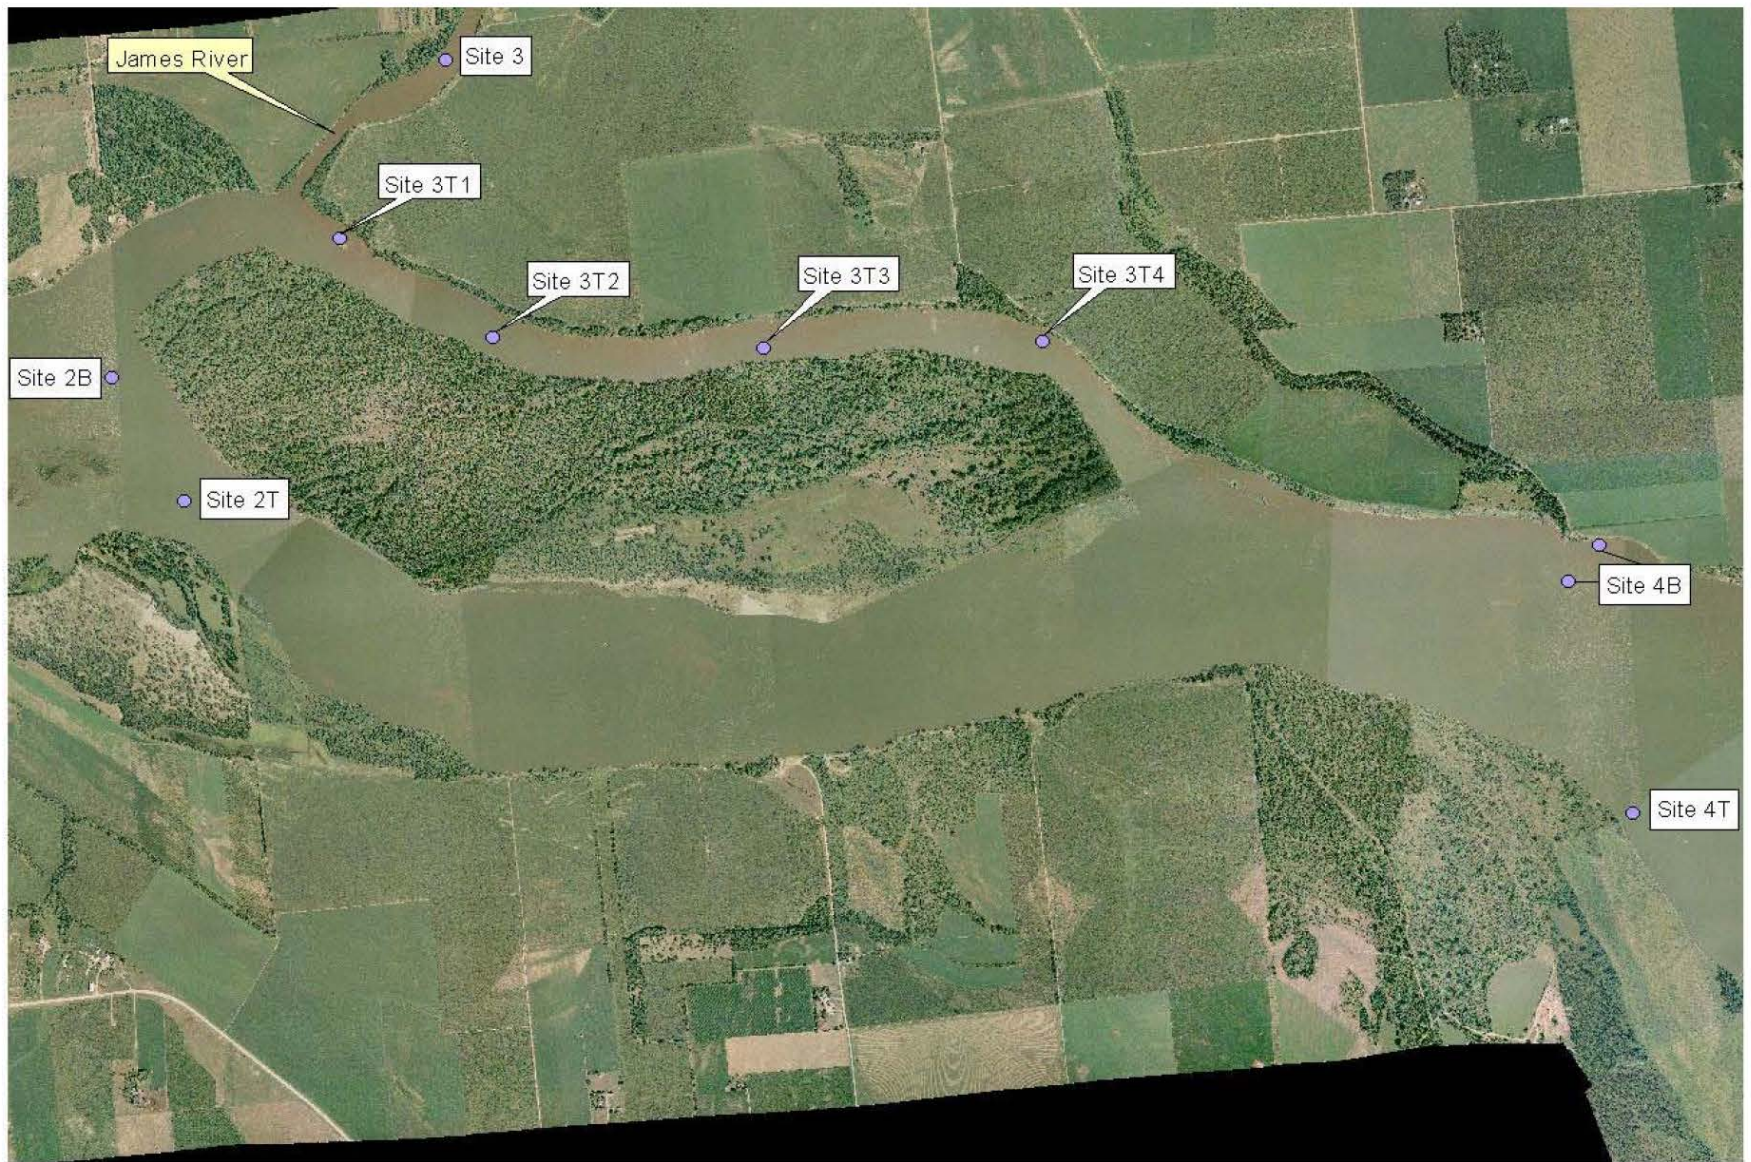
**Plate 5.** Location of Sites 2B, 2T, 3, 3T1, 3T2, 3T3, 3T4, 4B, and 4T based on the average of the obtained GPS coordinates and projected on a 1997 orthophoto of the area.

\* 4B(1) was located in a backwater area near the north bank of the Missouri River and was in a noticeable plume formed by the James River inflow. 4B(2) was in a backwater area away from the north bank and just on the edge of the James River plume. See Plate 5.

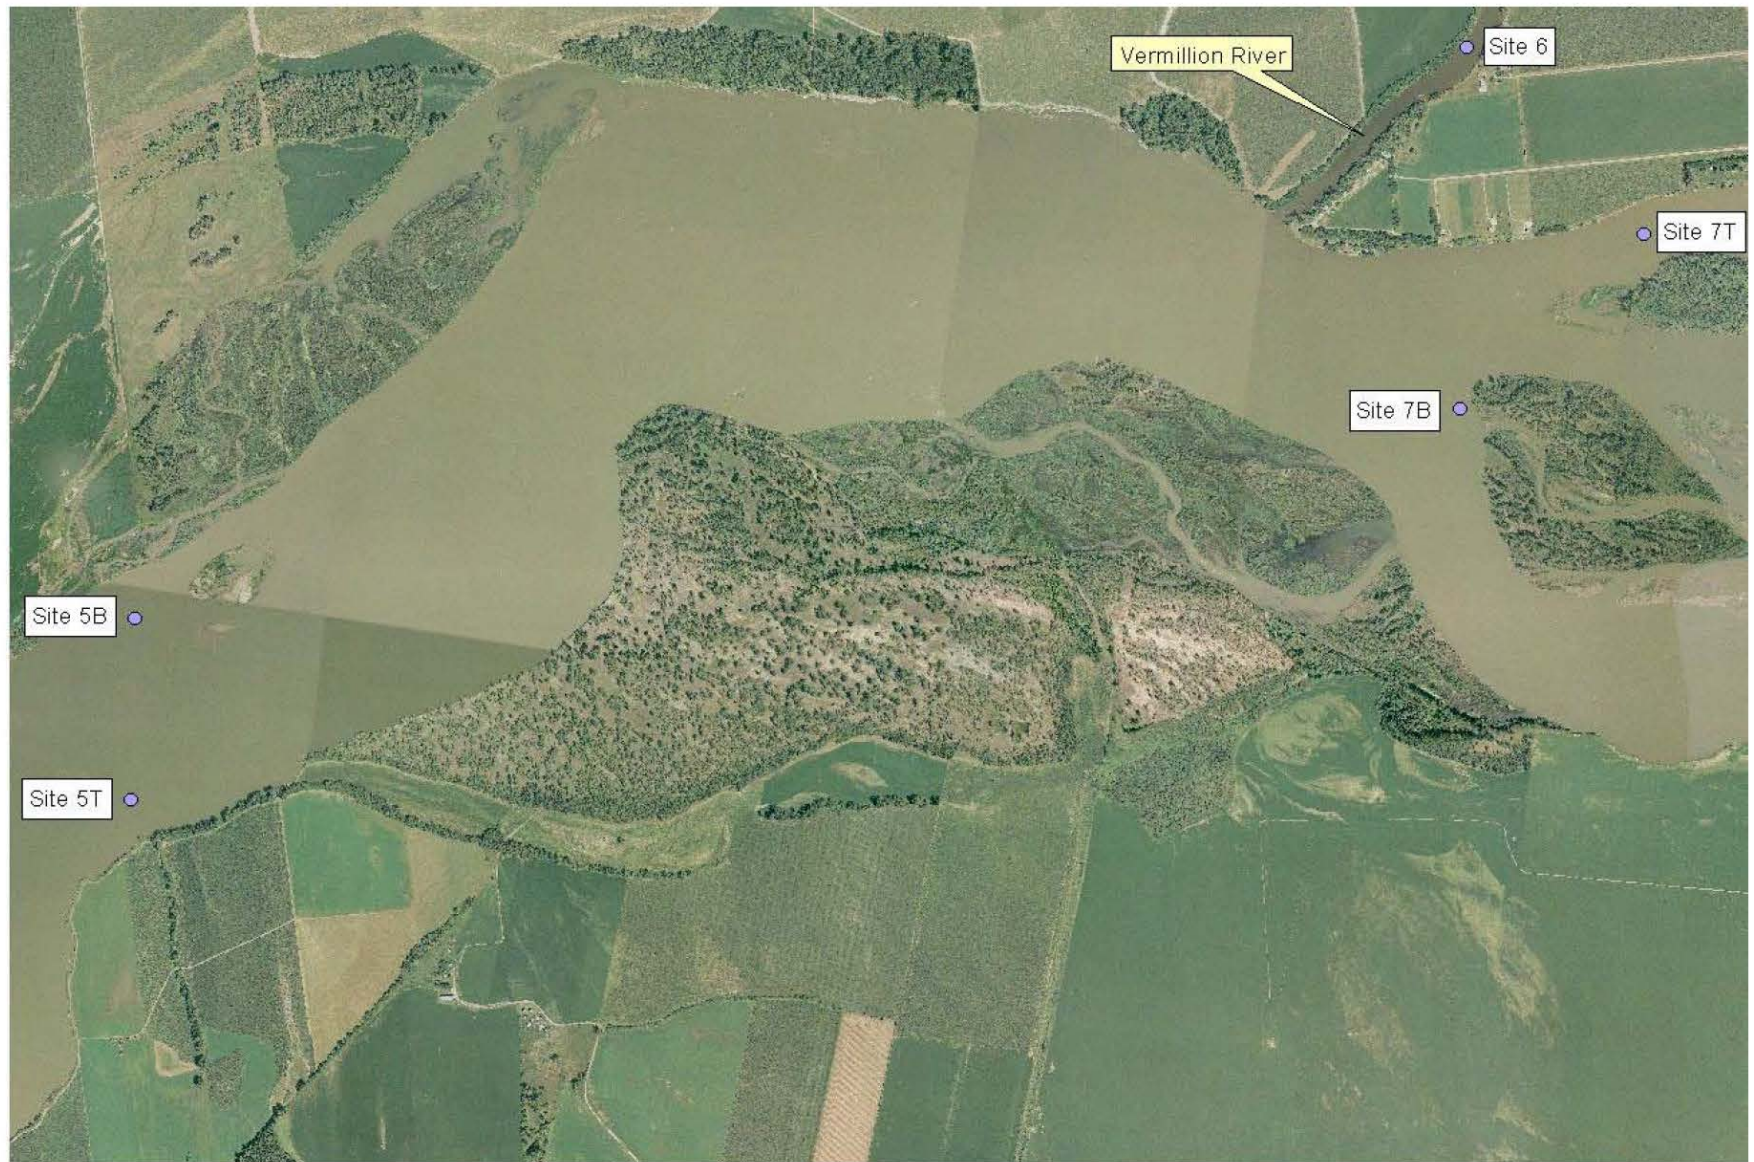
**Plate 6.** Location of Sites 5B, 5T, 6, 7B, and 7T based on the average of the obtained GPS coordinates and projected on a 1997 orthophoto of the area.

conductivity values calculated from the data collected at Sites 5Ts, 6, 7Ts, and 8Ts are given in Table 6. As seen in the mean conductivity value for Site 7Ts, a limited plume did occur below the inflow of the Vermillion River. Site 7Ts was located approximately one-half mile downstream from the mouth of the Vermillion River near the north bank (Plate 6).

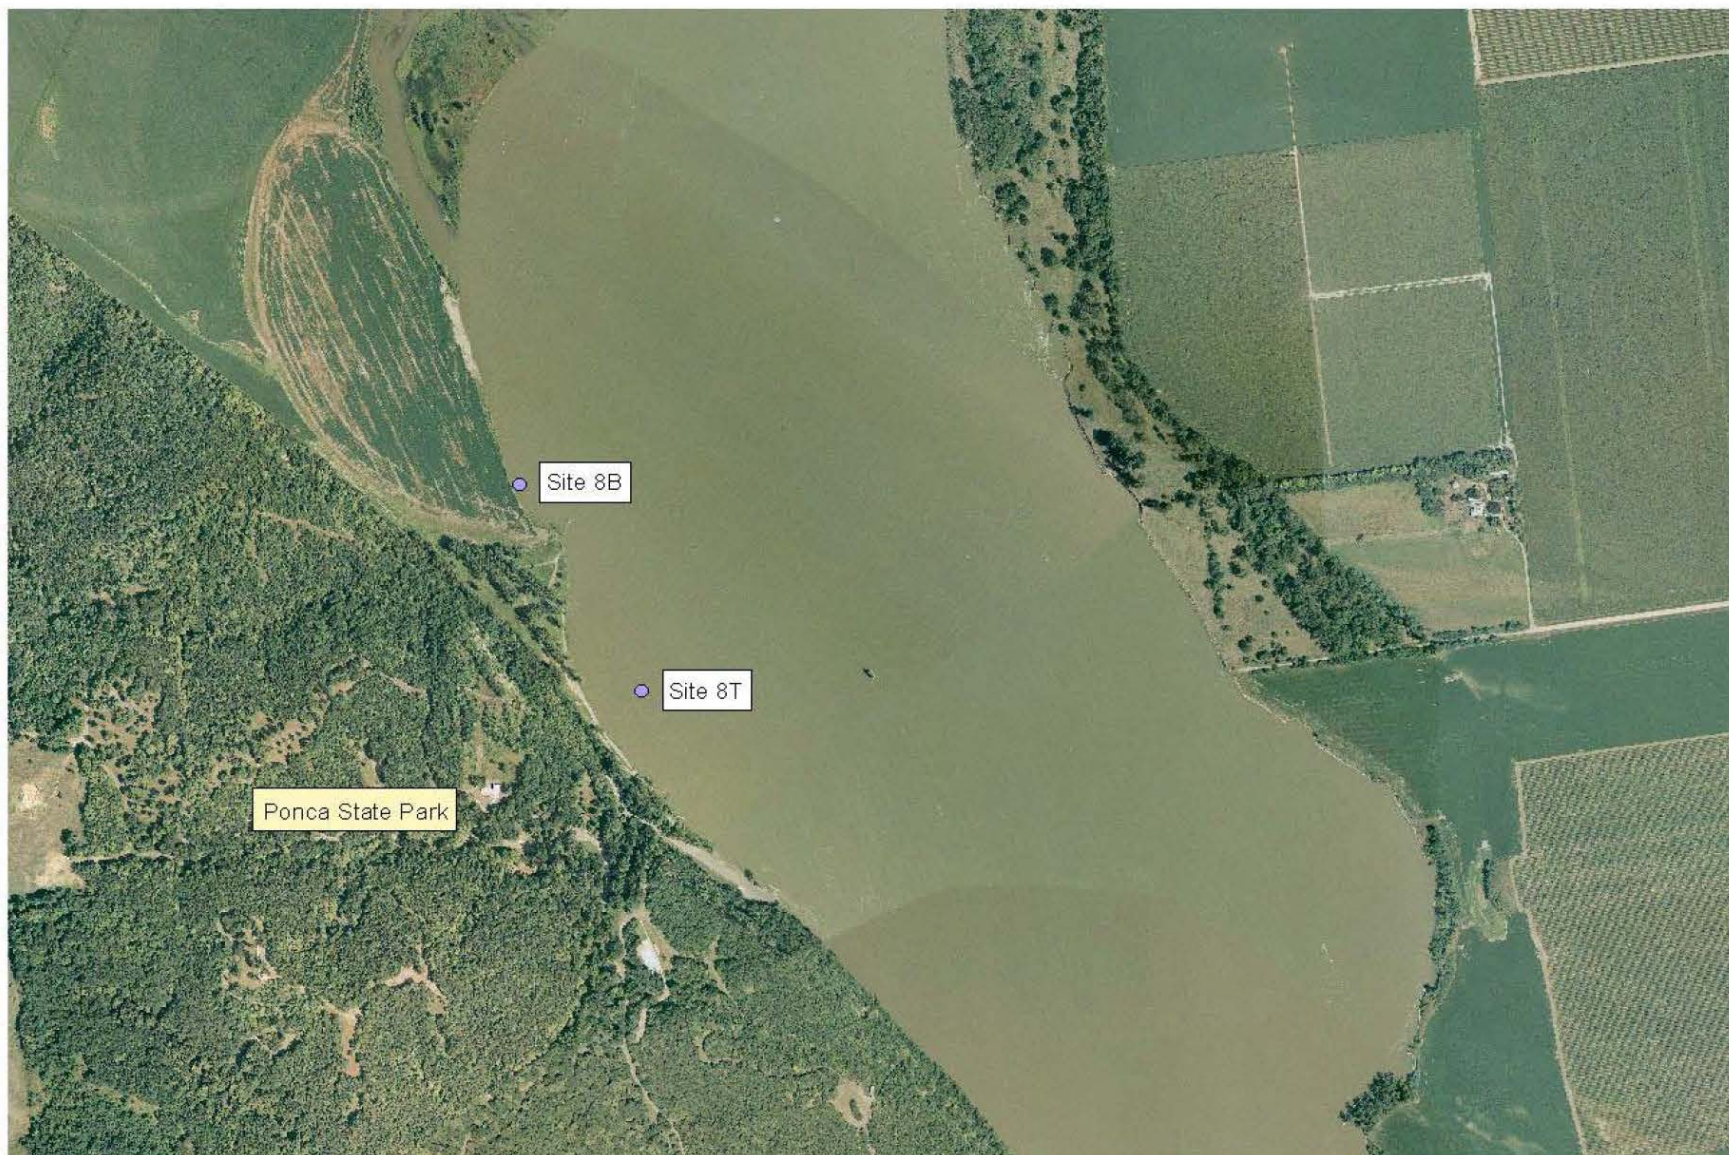
**Plate 7.** Location of Sites 8B and 8T based on the average of the obtained GPS coordinates and projected on a 1997 orthophoto of the area.

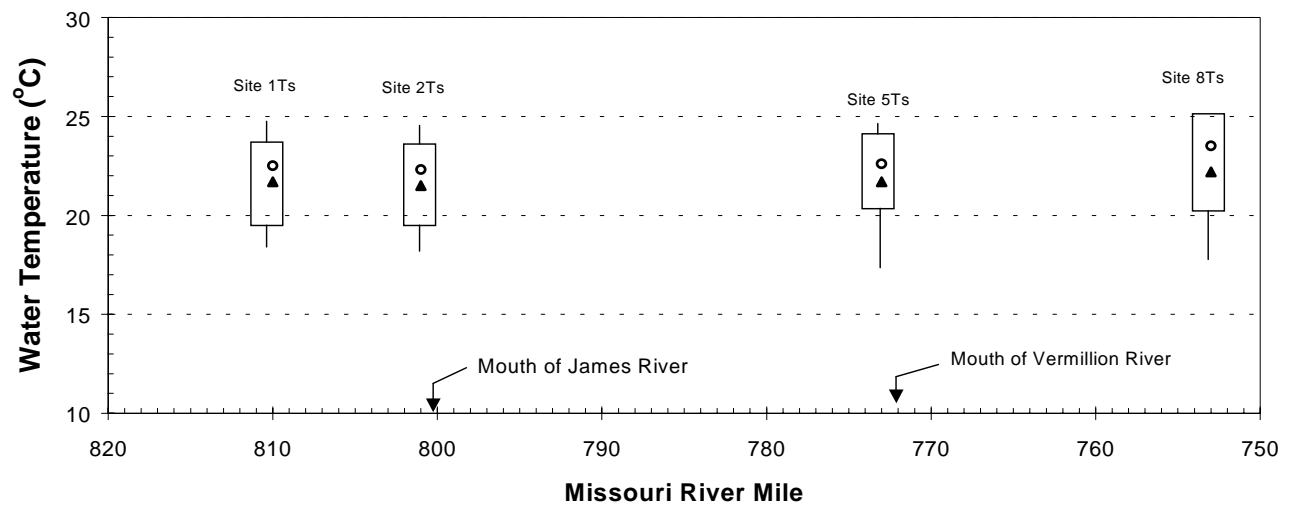
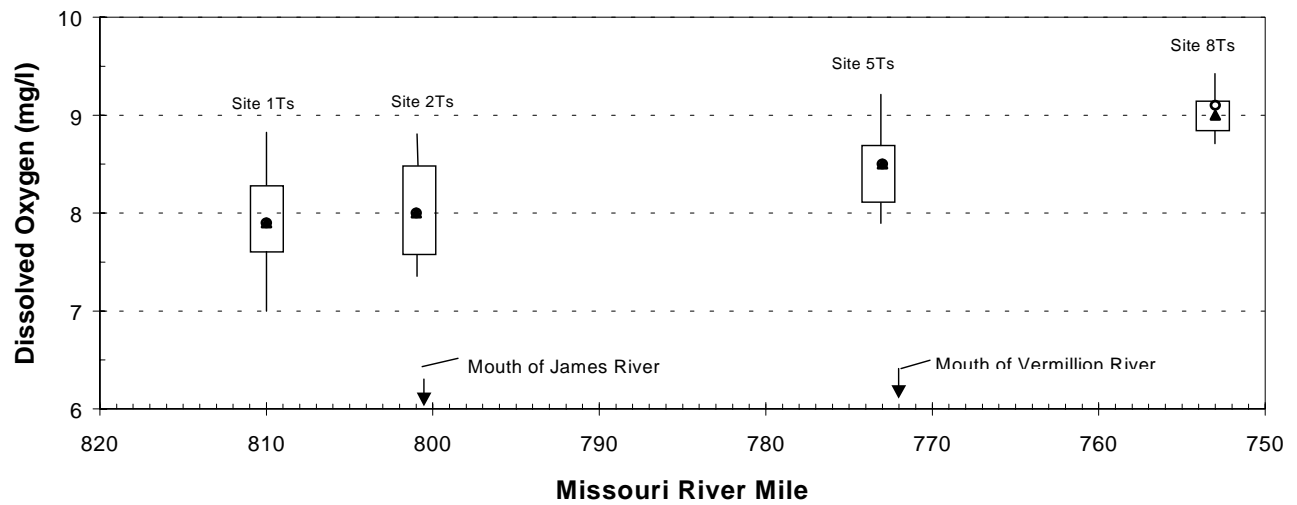
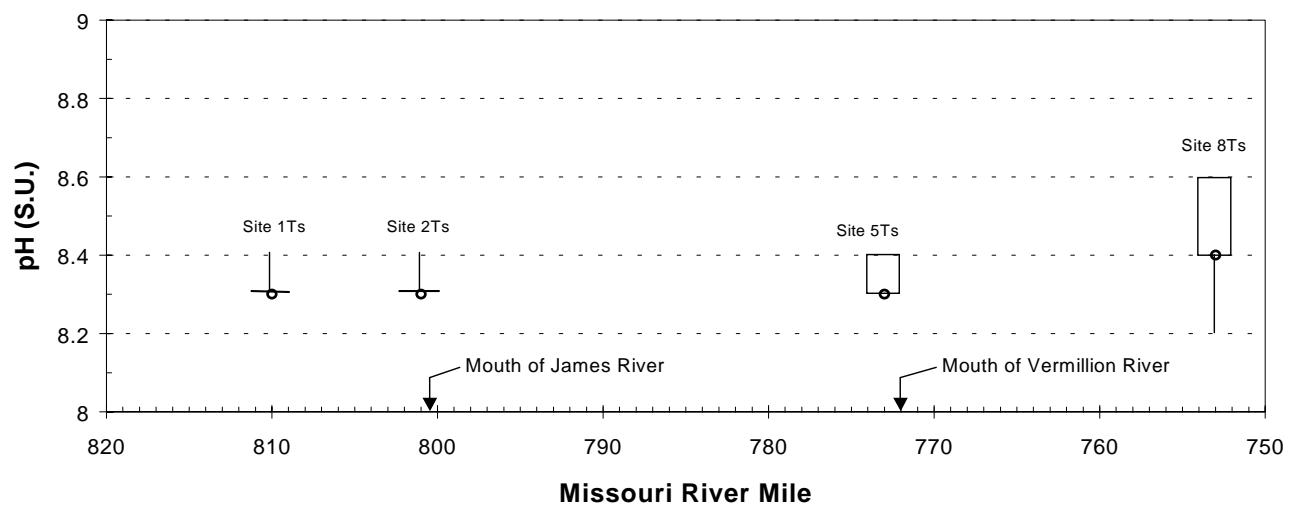
**Figure 9.** Box plots of water quality parameters monitored at Sites 1Ts, 2Ts, 5Ts, and 8Ts during the scoping study.

Monitoring results were used to construct box plots for each parameter measured, except alachlor and metolachlor, at Sites 1Ts, 2Ts, 5Ts, and 8Ts during the scoping study. As noted previously, all samples analyzed for alachlor and metolachlor were below method detection limits. The constructed parameter box plots were plotted, by site, on a graph where the x-axis represented Missouri River mileage points (Plate 9). Based on this graphical representation it was determined that water temperature, pH, total organic carbon, total Kjeldahl nitrogen, total ammonia, nitrate-nitrite, chlorophyll a, and atrazine exhibited no noticeable longitudinal variation through the MNRR reach; while, dissolved oxygen, conductivity, Secchi depth, turbidity, total suspended solids, and total phosphorus did. For the six parameters that exhibited longitudinal variation it was concluded that no noticeable difference existed between Sites 1Ts and 2Ts; however, there was a noticeable difference between Sites 2Ts and 5Ts for all six parameters and Sites 5Ts and 8Ts for all the parameters except conductivity. Statistical assessment (two-tailed, paired t-test) of the measured values obtained at Sites 2Ts and 5Ts

where there was a noticeable difference observed in Plate 9, found the following significance levels (rounded to two significant digits): conductivity ( $p = 0.02$ ), dissolved oxygen ( $p = 0.05$ ), Secchi depth ( $p = 0.03$ ), turbidity ( $p < 0.01$ ), total suspended solids ( $p < 0.01$ ), and total phosphorus ( $p < 0.01$ ). A similar assessment of the measured values obtained at Sites 5Ts and 8Ts found the following significance levels: dissolved oxygen ( $p = 0.04$ ), Secchi depth ( $p = 0.05$ ), turbidity ( $p = 0.02$ ), total suspended solids ( $p = 0.01$ ), and total phosphorus ( $p < 0.01$ ).

The differences between Sites 2Ts and 5Ts and Sites 5Ts and 8Ts for all the noted parameters except possibly dissolved oxygen are believed due to the respective inflows of the James and Vermillion Rivers. The differences in dissolved oxygen may be due to other factors. It is noted that the Sites 1Ts and 2Ts were sampled in the early morning, Site 5Ts was sampled around noon, and Site 8Ts was sampled in the late afternoon. The dissolved oxygen percent saturation levels measured at Sites 1Ts and 2Ts were in the low 90's, at Site 5Ts it was in the high 90's, and at Site 8Ts it was above 100%. This downstream pattern of increasing dissolved oxygen concentrations and percent saturations could be reflective of the "normal" diurnal changes in dissolved oxygen due to photosynthesis and respiration. It is also noted that the pattern could be the result of reoxygenation of lower oxygenated water discharged from the reservoir through Gavins Point Dam or a possible bias introduced into the measurements from meter drift.

The inflow of the James River appears to have a significant influence on turbidity levels in the Missouri River (Plate 9). During the scoping study a turbidity plume was observed below the mouth of the James River in the side channel of the Missouri River into which it enters. This turbidity plume can visually be seen in the 1997 orthophoto of the area (Plate 16). Mean turbidity, Secchi depth, and conductivity values calculated from the data collected at Sites 2Ts, 3, 3T1, 3T2, 3T3, 3T4, 4B and 5Ts are given in Table 6. The plume formed below the James River stays relatively intact throughout the entire length of the side-channel of the Missouri River into which it flows. As seen in the data collected at Site 4B, the plume still exists within the Missouri River one-half mile below where the side-channel rejoins the main river, but is dissipating (Table 6).

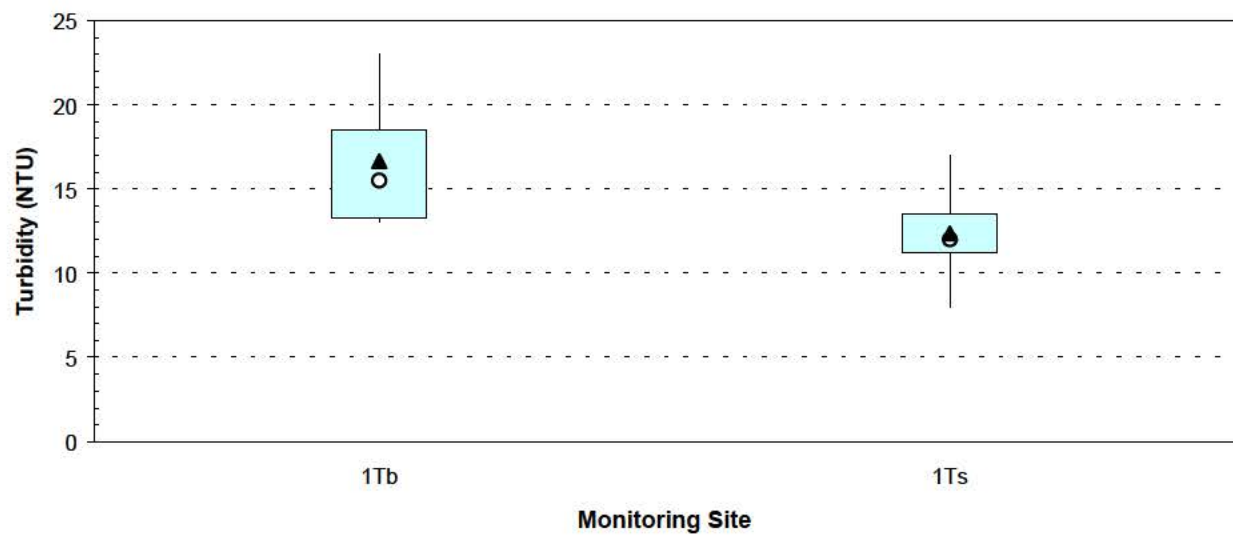
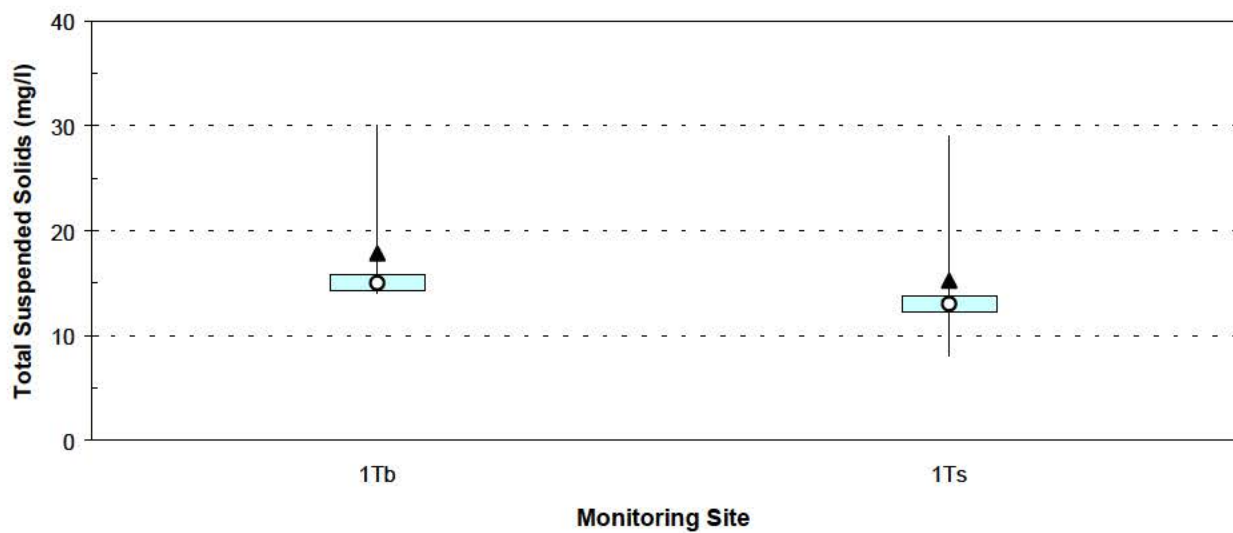
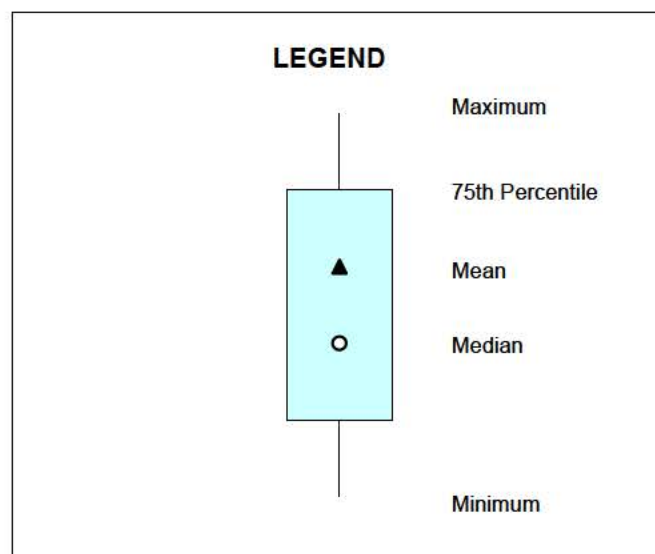
**Figure 10.** Boxplots of turbidity and total suspended solids levels for the near-bottom and near-surface thalweg samples collected at monitoring location 1.

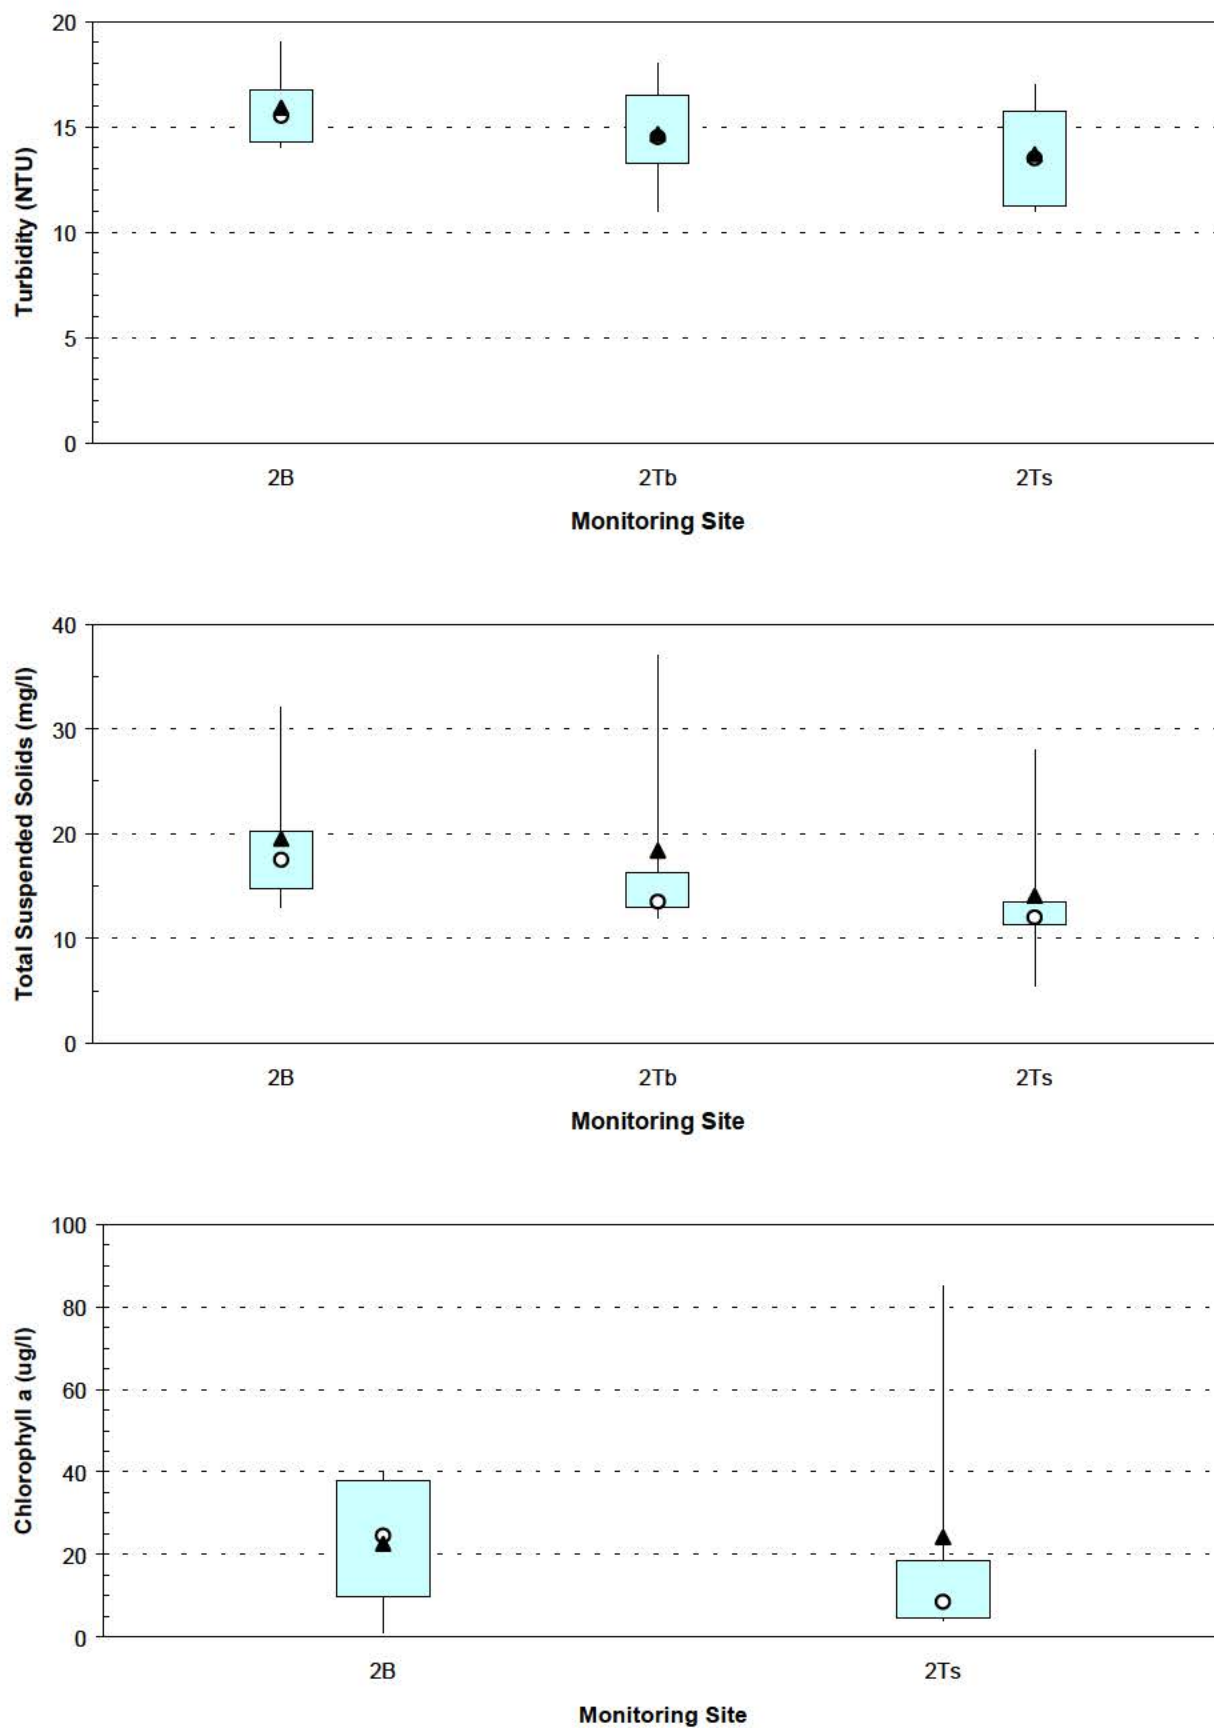
Figure 11. Boxplots of turbidity, total suspended solids, and chlorophyll a levels for the backwater and near-bottom and near-surface thalweg samples collected at monitoring location 2.

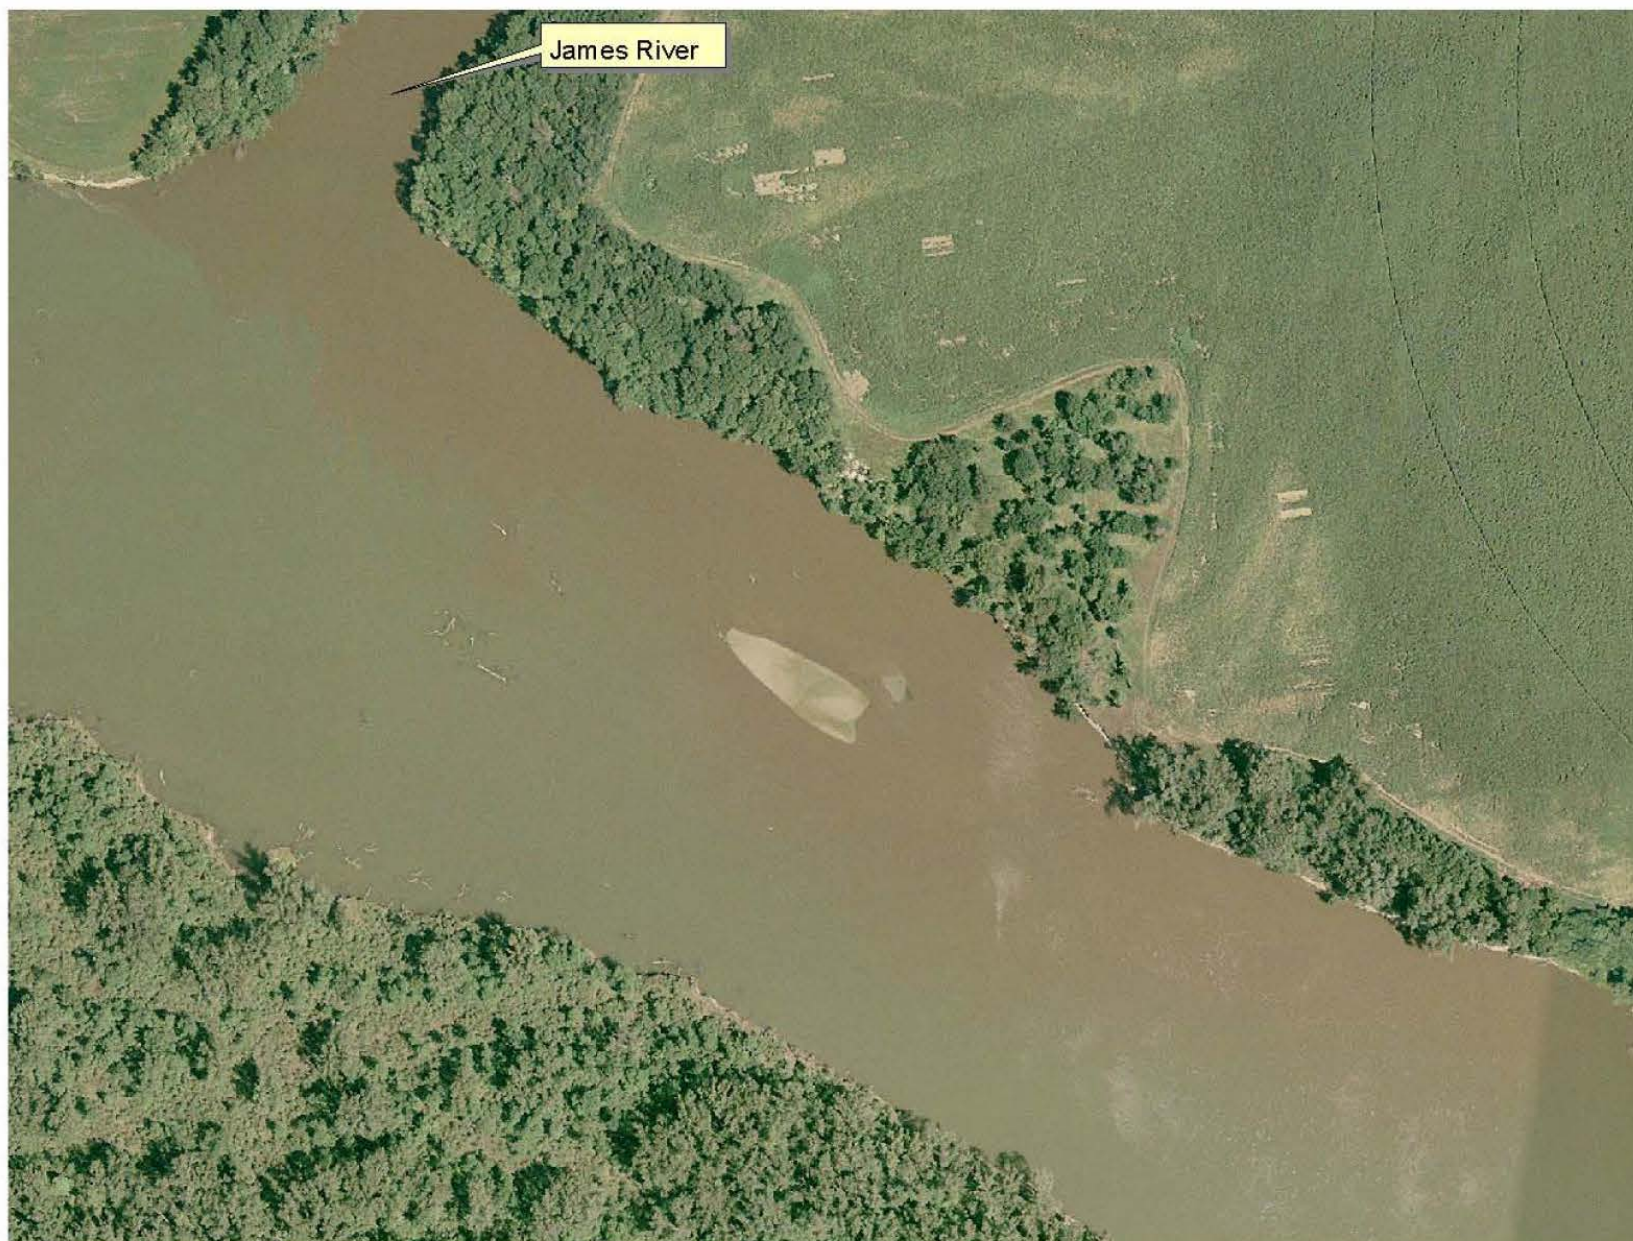
**Plate 16.** Area near the mouth of the James River as it enters a side channel of the Missouri River as depicted in a 1997 orthophoto of the area.
